# Rail Accident Investigation: Interim Report

**Collision between passenger trains near Elstow,  
Bedfordshire  
19 June 2026**

# Collision between passenger trains near Elstow, Bedfordshire, 19 June 2026

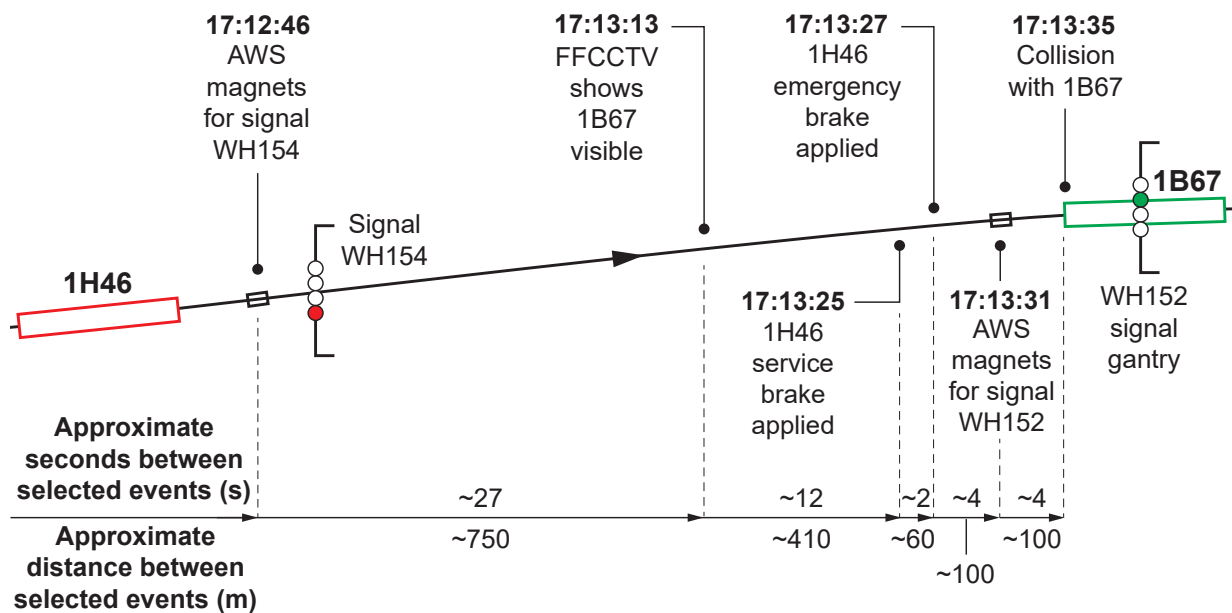
Figure 5: Train 1H46 approaching the rear of train 1B67 (not to scale and not all features shown for clarity).

- 53 At 17:12:46, train 1H46 received an AWS warning indication associated with signal WH154 (figure 5). FFCCTV images show that this signal was displaying a red aspect as the train approached. The OTDR from train 1H46 recorded that the driver acknowledged the AWS warning indication, but the train continued to accelerate towards and beyond the signal, which it passed at 17:12:53.
