**NPL REPORT ENG 63**

**AN EVALUATION OF POTENTIAL MATERIALS FOR THE HANDLING  
AND SUPPORT OF MASS STANDARDS IN VACUUM/INERT GAS  
APPARATUS**

**FEBRUARY 2016**

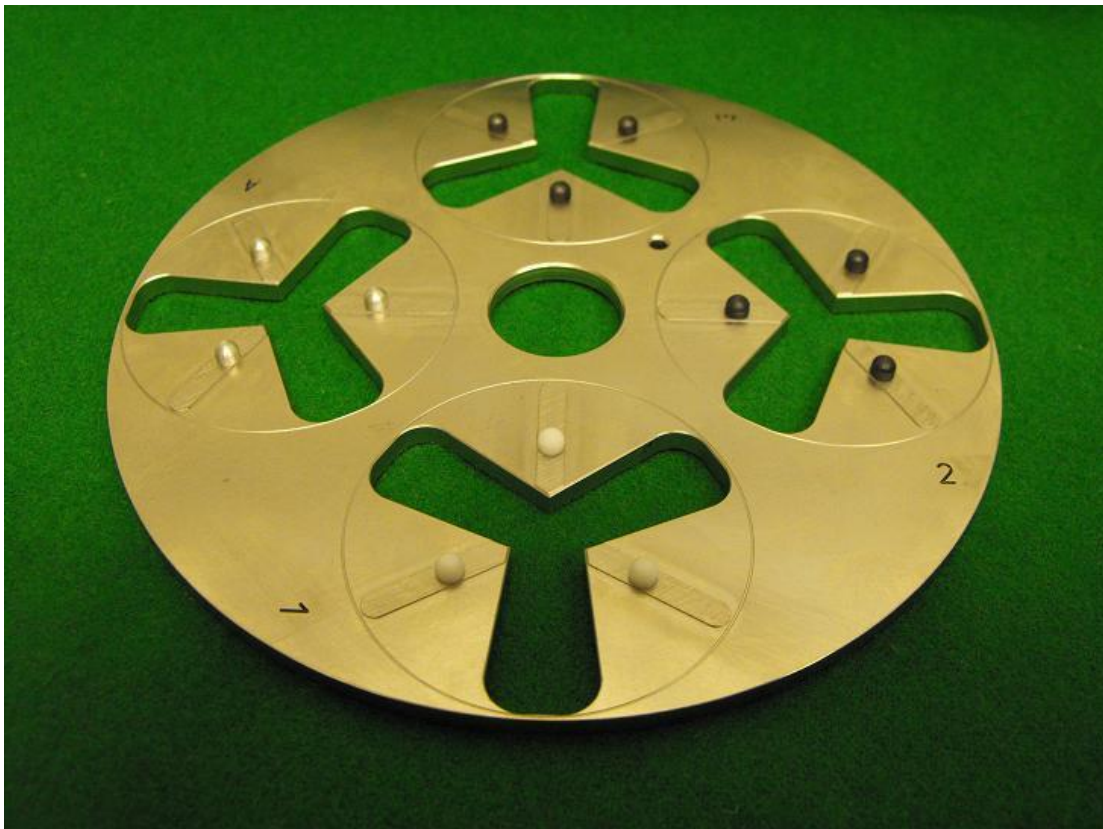
**Figure 1.** Modified turntable of the HK1000 mass comparator fitted with the test pegs manufactured from the support materials.

A Mettler-Toledo HK1000 mass comparator was used to repeatedly transfer the stainless steel artefacts onto the support materials. Three pegs of each support material were manufactured and inserted into holes machined into the comparator's turntable as shown in figure 1. The holes were machined at 120° intervals on a circle with a radius of 30 mm. The vertical motion of the HK1000 turntable was controlled using software on a computer so that the entire test process was fully automated.

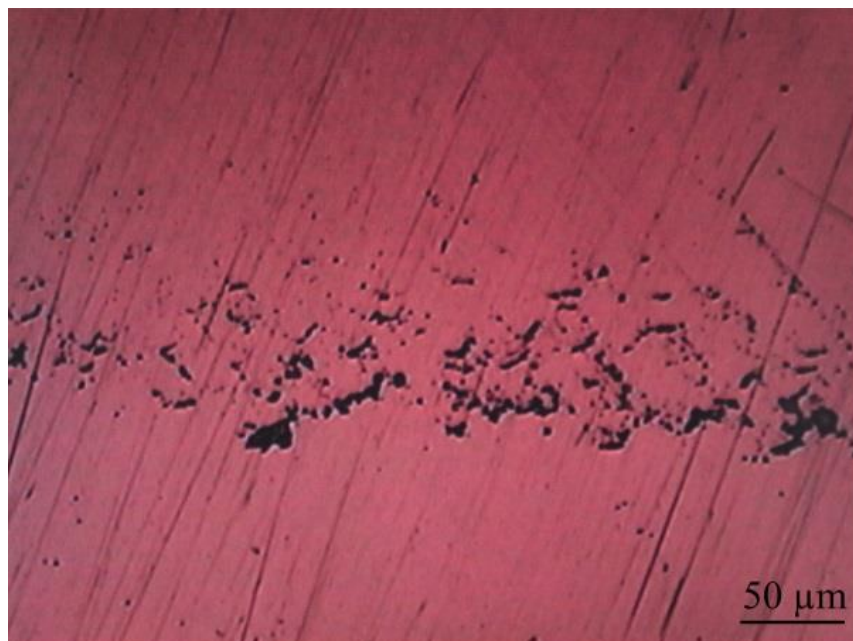
**Figure 20.** Optical microscope image of the contact area for PTFE.

Contact with PTFE did not cause the type of groove observed with the PEEK and aluminium tests. However, the optical microscope images do show marks on the surface as seen in figure 20. It can be seen from the AFM image shown in figure 21 that contact with the PTFE pegs did not cause indentations or depressions but there appeared to be considerable amount of contamination that had probably been transferred from the pegs. However, this contamination was negligible in terms of mass added to the artefact. These results were in contrast to the NPL PTFE contact tests which showed damage in the form of indentations on the surface of the artefacts in the CSI images (§ 4.4.2). The horizontal streaks observed in the AFM image shown in figure 21 were typical imaging artefacts and are not an indication of damage to the surface; these imaging artefacts may have arisen because the probe was unable to track sharp surface features as a result of improper feedback parameters.
