***NPL REPORT MAT 41***

**Procedures for Steam  
Oxidation Testing of Static  
and Dynamic Specimens**

**MARCH 2010**

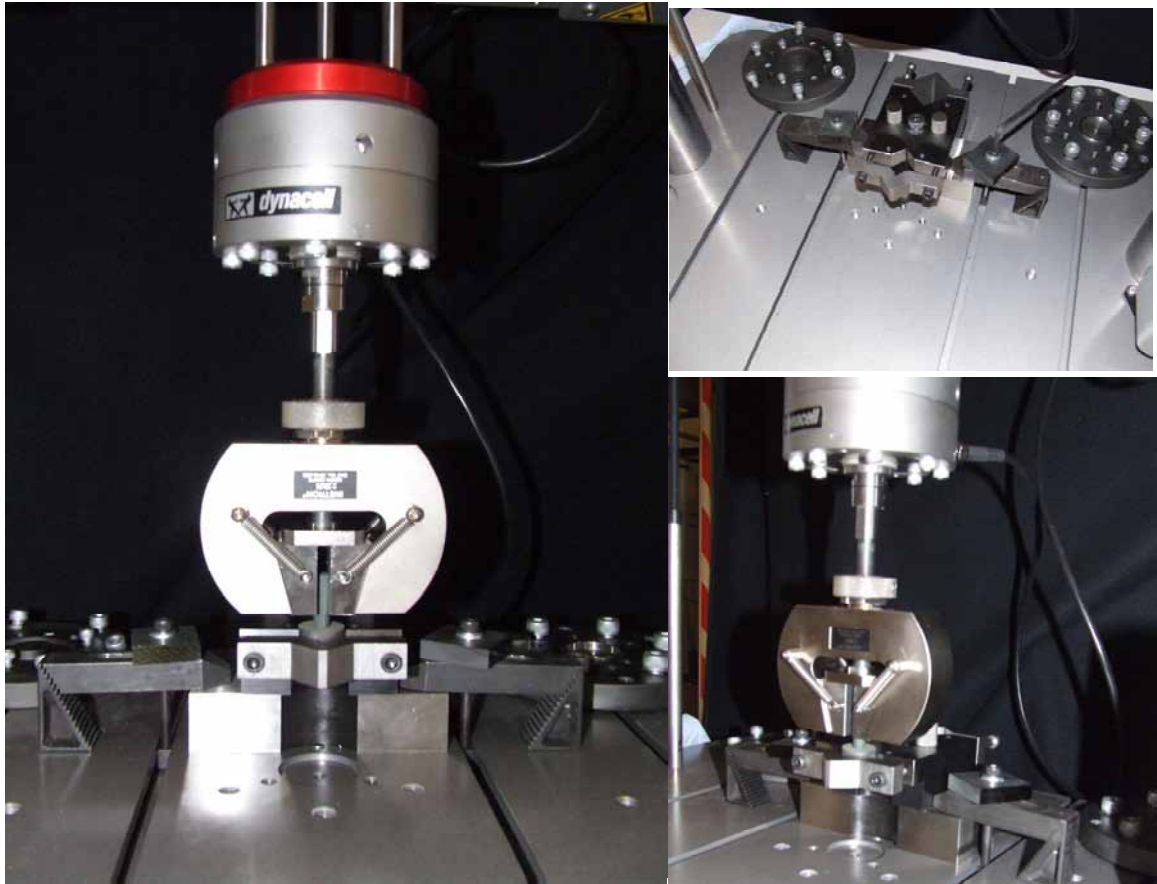
**Figure 5 Photo showing the gripping method used for the pin and collar samples in the ElcetroPuls tensile tester.**

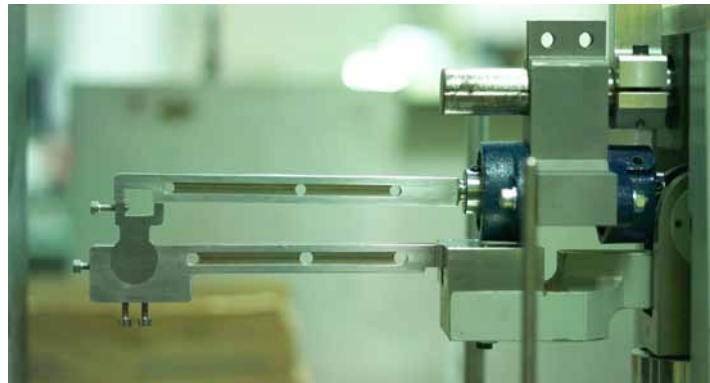
**Figure 11 Sample Holder Arms.**

The arms were designed specifically to allow the top and bottom surfaces to be positioned parallel to each other to ensure a flat contact between the top and bottom specimens. This was done by enabling the top arm to rotate clockwise and anti-clockwise with the lower specimen held in a holder which allowed lateral movement, see Figure 11.
