**EMRP SIB-05 DELIVERABLE 1.2.2**

**HOMOGENEITY AND RESISTANCE OF METAL ON METAL  
COATINGS**

**JUNE 2015**

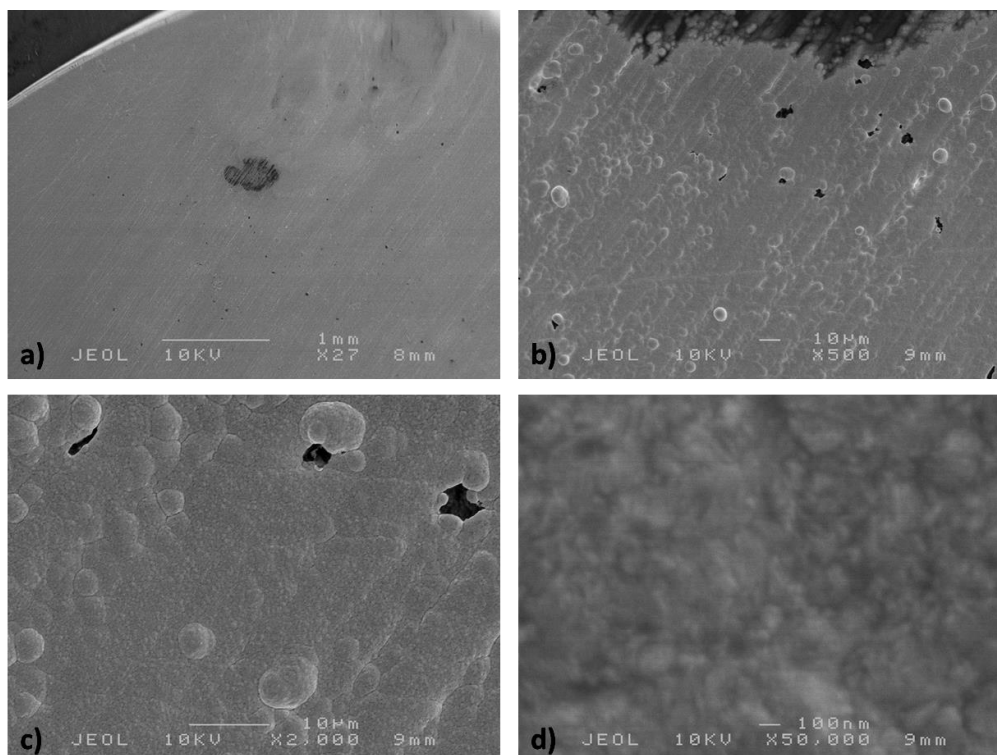
**Figures 1a to 1d. SEM micrographs of NRC prepared samples demonstrating the lateral homogeneity and roughness of the gold plating formed from TSG-250 precursor solution on OFHC copper at NRC. The images a,b,c,d were each obtained at different magnifications ( $\times 27$ ,  $\times 500$ ,  $\times 2,000$ ,  $\times 50,000$  respectively) as indicated by the incorporated scale bars in the image.**

Scanning electron micrographs for a sample plated using precursor TSG-250 are presented in figure 1. The macro-scale homogeneity is best demonstrated in figure 1a in which the area shown is approximately 5 mm  $\times$  4 mm. The edge of the sample can be seen in the top left of the image with one major area of depleted plating seen near the centre of the image. Small pin holes can be seen over most of the surface but the concentration of pin holes is smaller at the left side of the image with the leftmost 1 mm showing almost no pinholes. This indicates that the number of pinholes might be reduced by optimizing the properties of the underlying substrate. In figures 1b and 1c the pinholes are shown in higher magnification and can be seen to vary in shape and are generally in the 1  $\mu\text{m}$  - 5  $\mu\text{m}$  size range. It is not clear if the pin holes extend right down to the underlying substrate but this would be likely if disruption of the electrochemical plating reaction occurred at these points due, for example, to the presence of an oxide or other defect. The striations particularly visible in figure 1b are remnants of the machining process, and could be largely eliminated through surface polishing of the underlying copper which can be produced with a near optical finish. Figure 1d demonstrates the lateral roughness of the highest frequency observed in the images, it is likely that this is due to either the grain structure of the gold over layer or the topography of an amorphous overlayer.

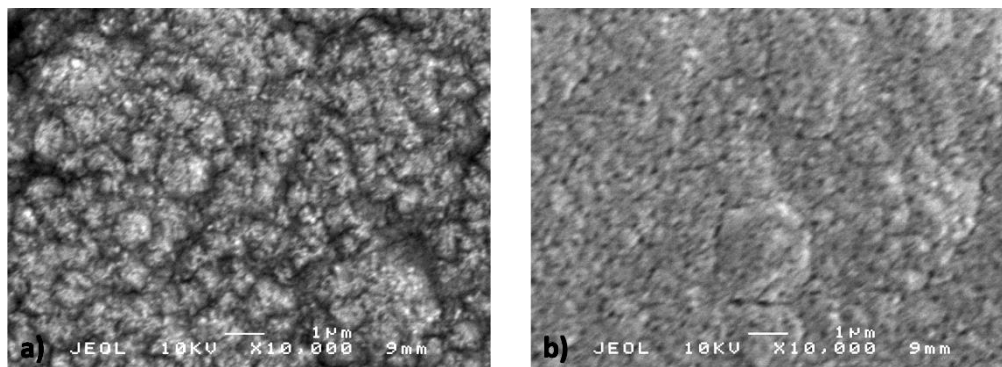
**Figures 2a and 2b. ( $\times 10,000$ ) Scanning electron micrographs of two random locations obtained under identical scan conditions. The difference between the images demonstrates the slight variation of surface structure with position. Au plated from TSG-250 precursor solution on OFHC copper at NRC.**

In figure 2 images of two different areas on the sample under the same imaging parameters are shown, at this scale some variation in the topography can be observed with the surface of figure 2a being slightly rougher than that of figure 2b. While SEM does not typically provide height information, the added contrast observed in figure 2a could indicate a higher vertical roughness when compared to figure 2b. The homogeneity observed in Figure 2b would be preferable for mass surfaces due to the smaller grain size and higher resulting smoothness. It is unclear if the difference observed between the regions shown in figures 2a and 2b are a consequence of the substrate inhomogeneity, local plating conditions or both, with some contribution due to changes in local imaging quality resulting from variable surface charging. Such conditions could be further explored to improve film quality.

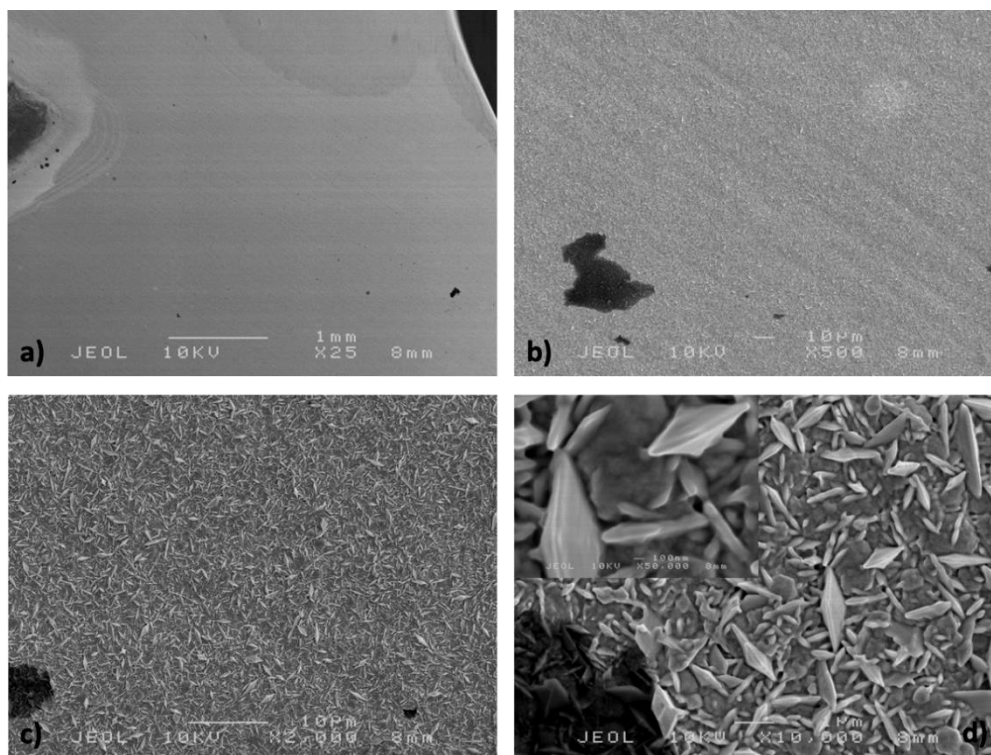
**Figures 3a to 3d. Scanning electron micrographs acquired at NRC of gold electroplated OFHC copper substrates using SG-10 pure gold as a precursor. The magnifications and scales are shown in the images ( $\times 27$ ,  $\times 500$ ,  $\times 2,000$ ,  $\times 10,000$ ,  $\times 50,000$  for figures a, b, c, d and the inset respectively) The coating is composed of crystallites with a range of sizes up to nearly  $2\text{ }\mu\text{m}$ .**

Figure 3 shows scanning electron micrographs of gold plating using SG-10 as precursor at the same magnifications as presented in figure 1 a-c and figure 2. For this image set figure 3a shows a fairly homogeneous surface at low magnification except for a large defect near the left side likely arising due to surface defects of the substrate. At higher magnification crystallites begin to become apparent with the high contrast in figure 3c and 3d possibly indicating higher vertical roughness as compared to the surface produced using TSG-250 precursor. Moreover figure 3d and its inset show large crystalites in the 100 nm to 2  $\mu\text{m}$  range along the long axis. The symmetry of the crystals indicates that the  $R_z$  roughness could be of the same order, though this is difficult to confirm via SEM. Interestingly, the dark region seen in figure 3b as imaged in higher magnification at the bottom left corner of figure 3d clearly demonstrates that the region is still coated and could appear darker due to reduced surface charge over the area or a variation in the chemistry of the plating material or perhaps the underlying substrate over the area. No pin holes are obvious in the images, though the shape of the crystalites makes absolute confirmation difficult.

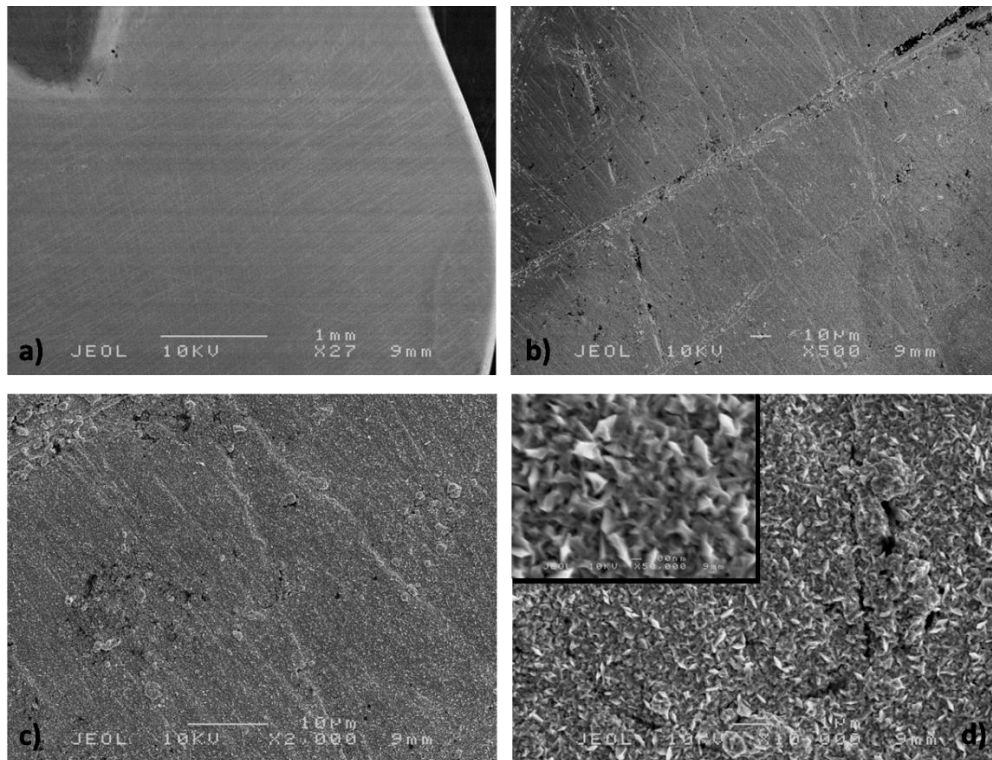
**Figures 4a to 4d. Scanning electron micrographs of NRC gold electroplated OFHC copper substrates using Orotemp 24 pure gold as a precursor. The magnifications and scales are shown in the images ( $\times 27$ ,  $\times 500$ ,  $\times 2,000$ ,  $\times 10,000$ ,  $\times 50,000$  for figures a, b, c, d and the inset respectively).**

In figure 4 the SEM micrographs of electroplated gold on copper derived from commercial Orotemp 24 precursor is presented. These micrographs were acquired at the same magnification as those presented for the previous precursors. At the lowest magnification, no pin holes are observed as they were for precursor 1 and again a large defect, likely a result of the underlying substrate, is observed in the top left part of figure 4a. The surface otherwise appears quite homogeneous at this magnification. Pinholes become apparent in figure 4b with areas along the heaviest substrate striations showing poor coverage. Cracks in the surface coating are observed in figures 4c and 3d, with the underlying crystallite composition of the coating becoming especially apparent in figure 4d and its inset. The crystallites are significantly smaller than those observed in the coating produced from precursor 2 with the vast majority under  $0.5\text{ }\mu\text{m}$  along the major axis. The crystallites are nominally the same shape as for precursor 2 and the  $R_z$  roughness not including the cracks or striations is estimated to lie between precursor 1 and 2. The smaller sized crystals could be a property of the coating or possibly a result of a lower deposition rate of the precursor that led to smaller amount of gold being deposited and a thinner coating. A thinner coating compared to precursors 1 and 2 could also explain the high number of defects observed especially if they derive from the underlying substrate. The influence of the substrate on the coating would be reduced with higher thickness.

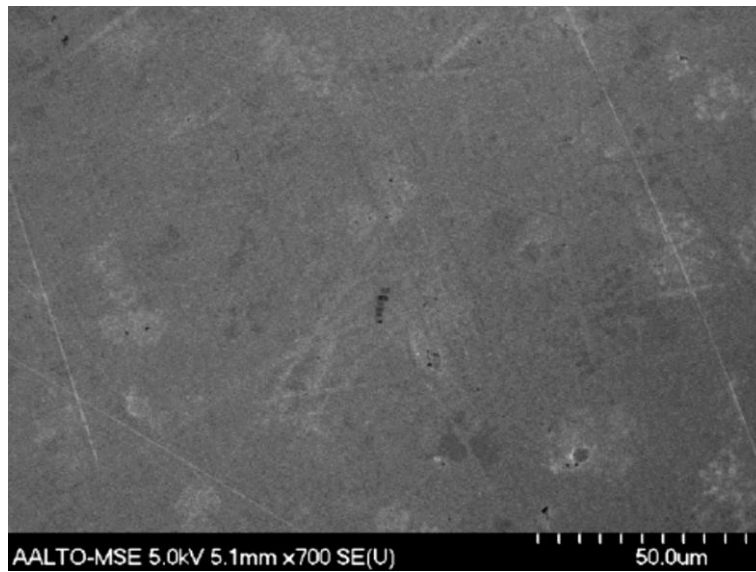
**Figure 5. SEM micrograph at  $\times 700$  magnification of gold-electroplated copper surface produced by Häfner.**

The Häfner gold plated samples were examined using X-ray Photoelectron Spectroscopy (XPS) and Atomic Force Microscopy (AFM) at MIKES. The gold surface was found smooth and homogenous indicating that the coating of the copper was successful (figures 5-7). Moreover, very little surface contamination and only single randomly oriented grooves were found. At higher magnifications the microstructure of the epitaxially grown gold film is clearly seen. The grain size of the film was about 500 nm.

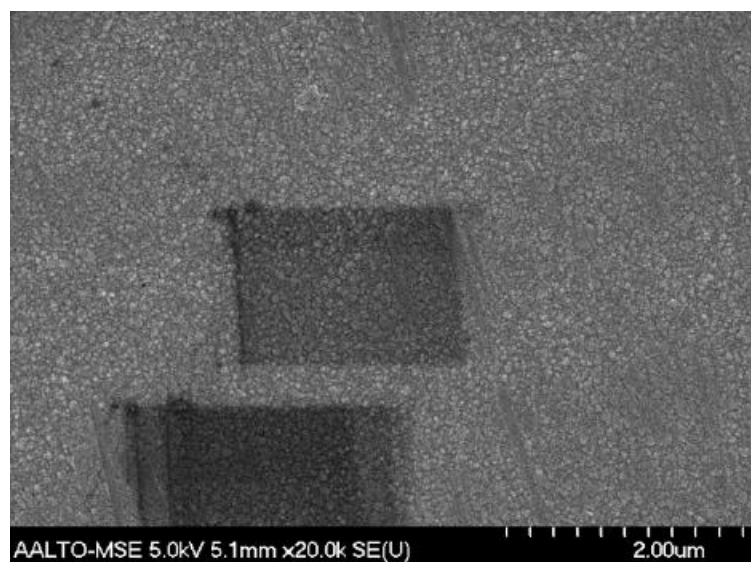
**Figure 6. SEM micrograph at  $\times 20,000$  magnification of gold-electroplated copper surface produced by Häfner.**

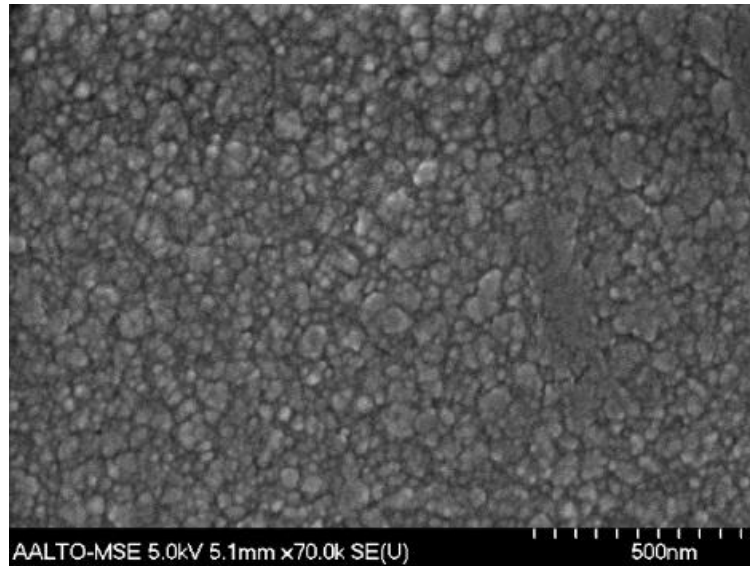
**Figure 7. SEM micrograph at  $\times 70,000$  magnification of gold electroplated copper surface produced by Häfner.**

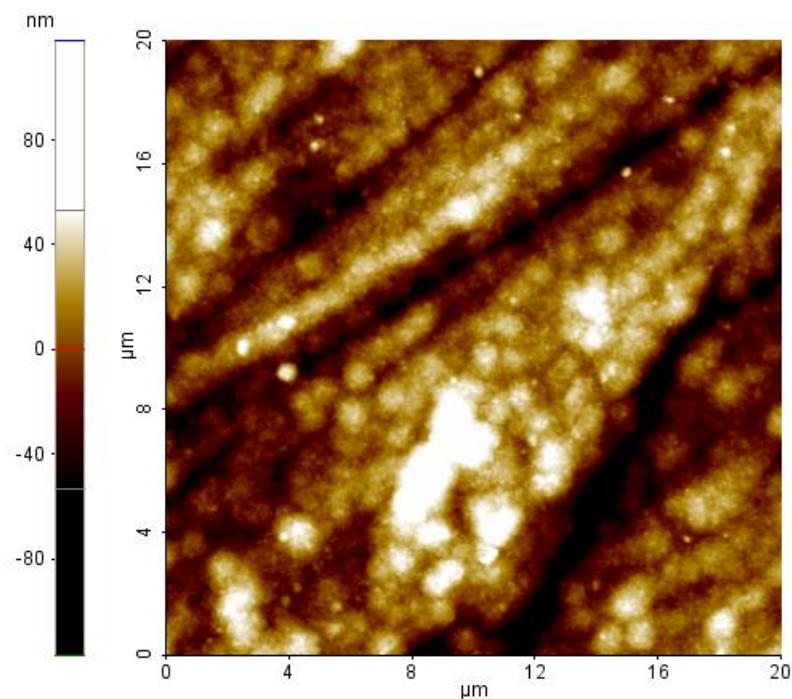
**Figure 8. AFM topography image of gold-electroplated copper surface produced by Häfner, taken with a scan size of  $20\text{ }\mu\text{m} \times 20\text{ }\mu\text{m}$ .**

The AFM images of gold-electroplated copper surface (figures 8 and 9) are similar to the SEM images. The surface coating was found to be homogenous with a grain size of about 500 nm similar to the sample studied with SEM. Also, the sample showed very little surface contamination.

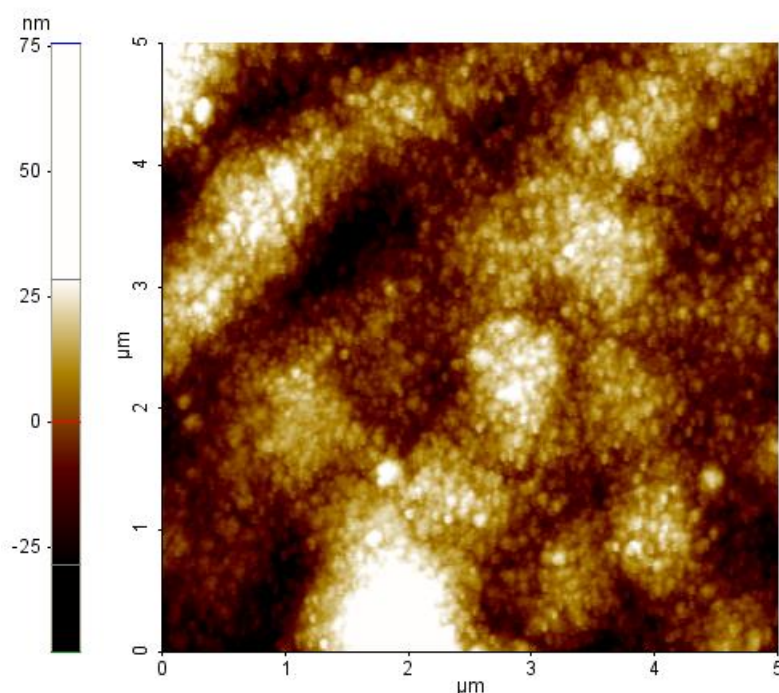
**Figure 9. AFM topography image of gold-electroplated copper surface produced by Häfner, taken with a scan size of 5  $\mu\text{m}$   $\times$  5  $\mu\text{m}$ .**

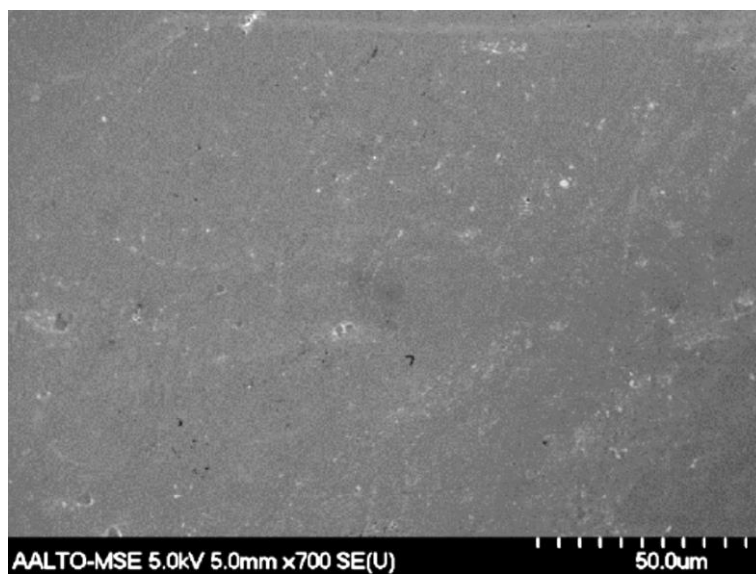
**Figure 10. SEM micrograph at  $\times 700$  magnification of rhodium-electroplated copper surface produced by Häfner.**

The rhodium plated copper surface was also found to be homogenous and smooth (figures 10-12). Almost no surface contamination or grooves were found on the surface. Overall, the rhodium coating was found to be more homogenous than the gold coating. The grain size of the electroplated layer was less than 500 nm.

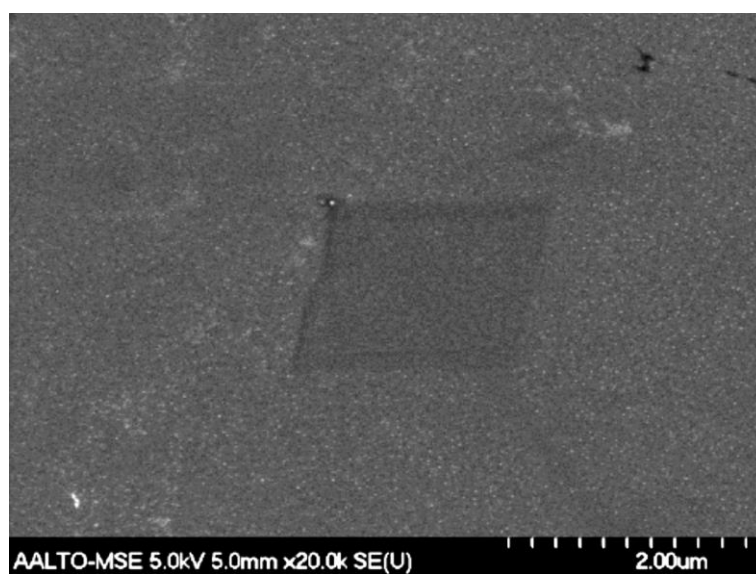
**Figure 11. SEM micrograph at  $\times 20,000$  magnification of rhodium-electroplated copper surface produced by Häfner.**

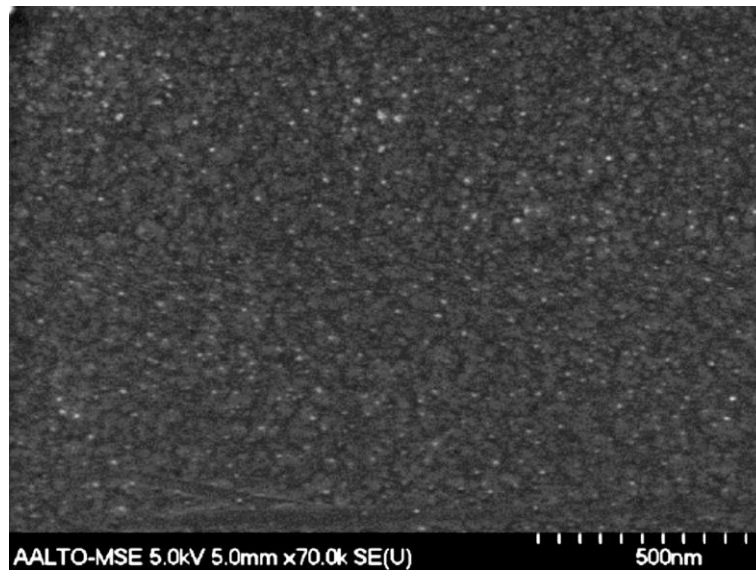
**Figure 12. SEM micrograph at  $\times 70,000$  magnification of rhodium-electroplated copper surface produced by Häfner.**

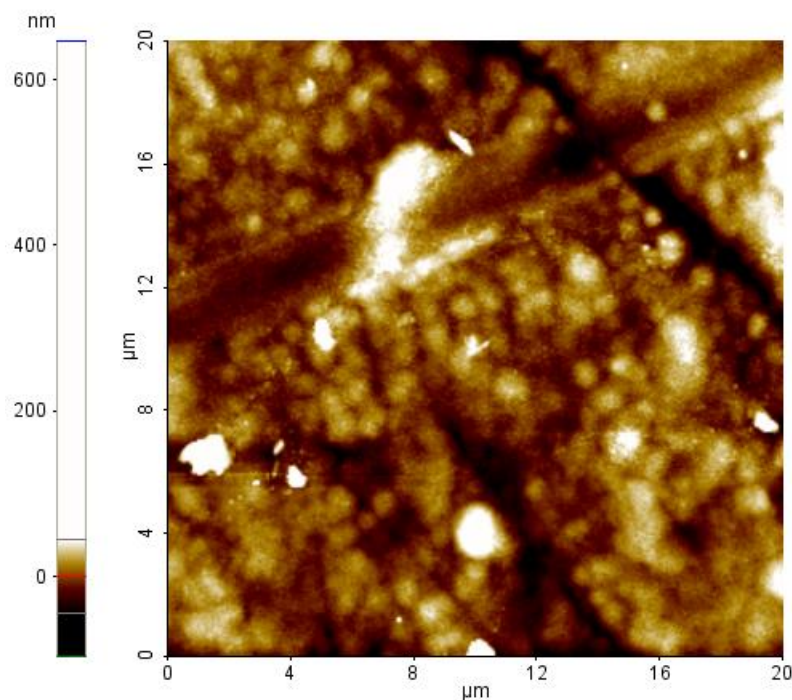
**Figure 13. AFM topography image of rhodium-electroplated copper surface produced by Häfner, taken with a scan size of  $20 \times 20\text{ }\mu\text{m}$ .**

The rhodium-plated copper surface analysed with AFM was different from the sample analysed with SEM. Surface contamination and grooves were found contrary to the SEM analysed sample. However, the grain size was found to be similar to that of the SEM samples. From the SEM image with  $\times 70,000$  magnification (figure 12) and the AFM image with  $5\text{ }\mu\text{m} \times 5\text{ }\mu\text{m}$  scan size (figure 14) protuberances can be seen (as small bright dots). According to AFM analyses, these protuberances were about 50 nm in diameter and 5 nm high. They are probably not surface contamination but rather residual material left over from the coating process.

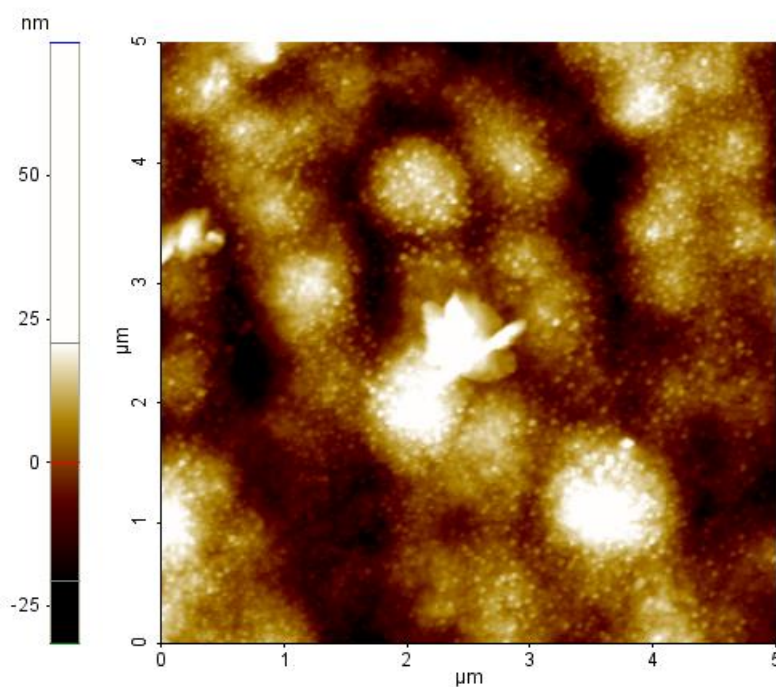
**Figure 14. AFM topography image of rhodium-electroplated copper surface produced by Häfner, taken with a scan size of  $5 \times 5 \mu\text{m}$ .**

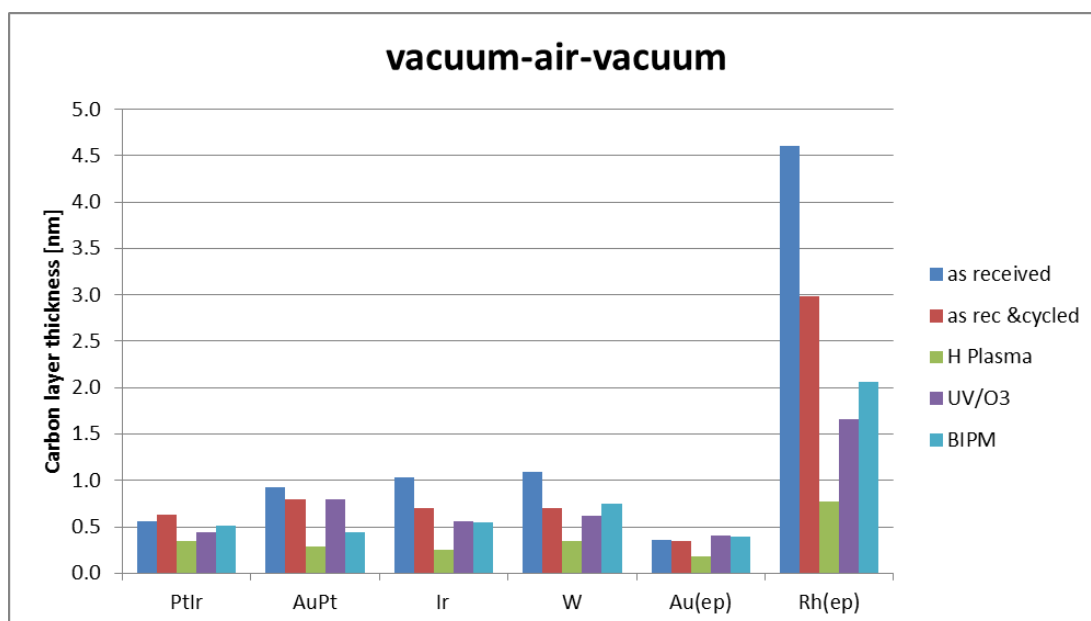
**Figure 15. Carbon-layer thickness for different materials as received and after vacuum cycling and undergoing various cleaning processes.**

The cleanliness and chemical composition of the samples was determined using XPS at EJPD. The instrument consists of an alpha110 detector and a twin anode x-ray source from Thermo Fisher Corp. All samples exhibited a natural contamination of roughly a monolayer of oxygen and carbon compounds, which is quite normal for samples exposed to ambient air. Beside this natural contamination the coating showed a homogenous gold spectrum. No other element species were detected. The extent of the carbonaceous surface contamination of the Häfner gold and rhodium plated samples (compared unplated metallic samples) before and after cleaning is shown in figure 15.

The cleanliness and chemical composition of the samples was determined using XPS. The instrument consists of an alpha110 detector and a twin anode x-ray source from Thermo Fisher Corp. All samples exhibit significant contamination when compared with other (plated and metallic) samples tested. No other element species were detected. The extent of the carbonaceous surface contamination of the Häfner gold and rhodium plated samples (compared unplated metallic samples) before and after cleaning is shown in figure 15.

The carbonaceous contamination shown in figure 15 indicates that, as received from Häfner, the gold plated surface showed slightly less carbonaceous contamination than the other non-plated materials. The rhodium plated surface had significantly more carbonaceous contamination some of which was removed (with various levels of effectiveness) by the individual cleaning processes identified. However, the residual carbon contamination was still greater than for the other samples.

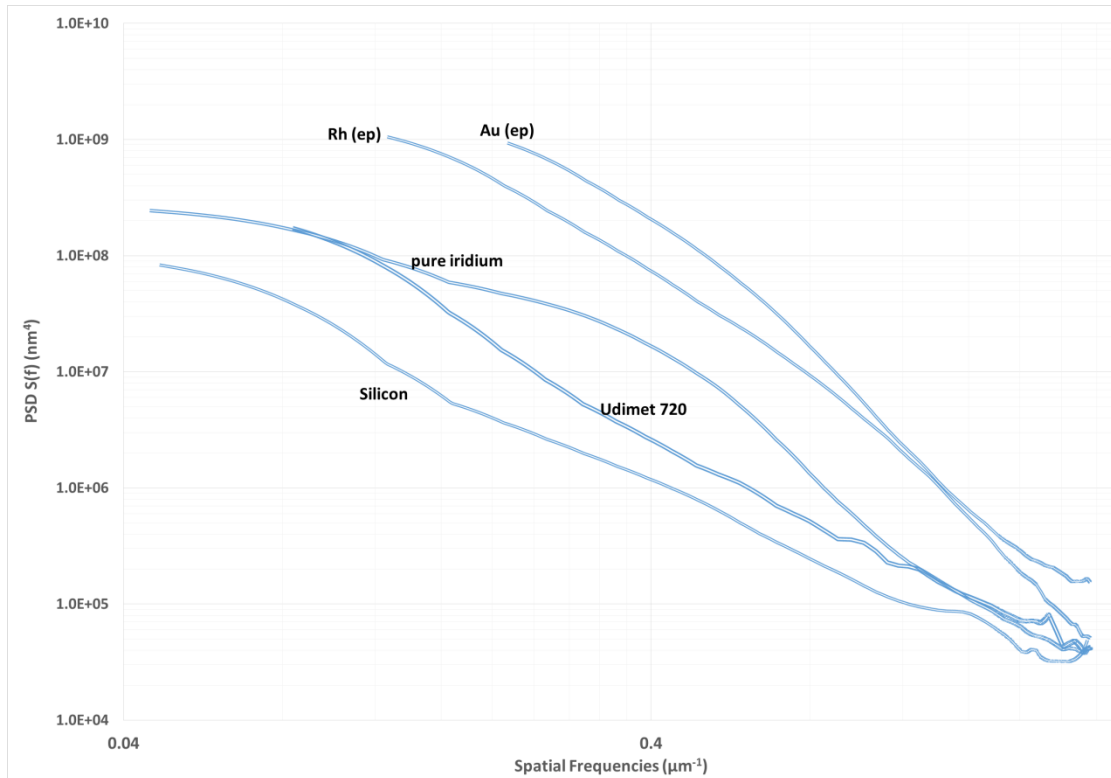
**Figure 16. Laser scattering from different surfaces to measure roughness. Mean power spectral density curves for silicon, gold-electroplated copper Au(ep) and rhodium electroplated copper and Rh(ep). Comparison with iridium, silicon and Udimet 720. The PSD has dimensions of  $[L^4]$  as the scattering is two-dimensional. Specular reflection prevented measurements of the lowest spatial frequencies in some cases. See Zerrrouki *et al.* [1] for more details.**

The surface roughness was characterized using three different methods: laser scattering (Cnam), atomic force microscopy (MIKES) and white light scattering (EPJD). Figure 16 shows results obtained using the first method and presents mean power spectral density (PSD) of each sample analyzed in the spatial frequency range  $0.1 \mu\text{m}^{-1} - 2.7 \mu\text{m}^{-1}$ . From these PSDs, the RMS height is extracted (see table 2). From the comparison of the PSDs, we can note that each material has a characteristic PSD shape and amplitude. PSD is a signature of the surface roughness in a given spatial frequency domain and provides information complementary to the RMS height values. PSDs amplitude are higher for Au (ep) and Rh (ep) compared with Ir, Udimet 720 and Si.

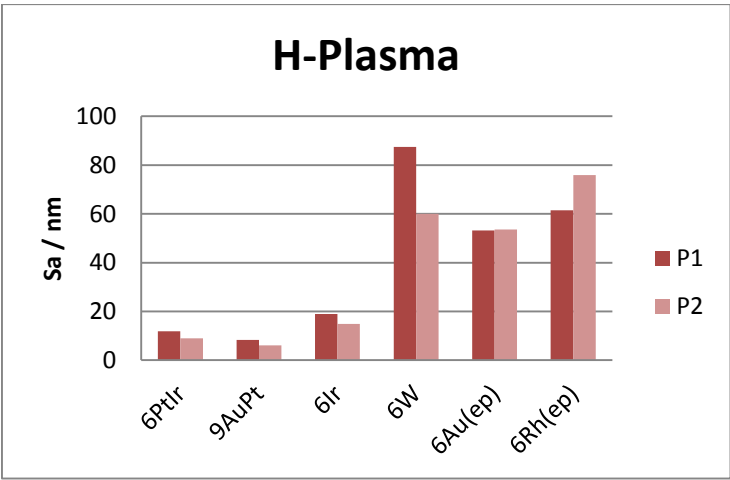
Figure 17.  $S_a$  surface roughness values for H-plasma cleaned samples (measurements taken at 2 positions, P1 and P2, on the sample surface).

EJPD performed comparative measurements via white light interferometry using a white light microscope (image size  $718 \mu\text{m} \times 546 \mu\text{m}$ ). Primary Profile Filtering used a noise filter Cut-off, at  $\lambda_s = 2.5 \mu\text{m}$ . Measurements were made according to ISO 4287 with a cut-off wavelength, of  $80 \mu\text{m}$ . The samples under investigation were cleaned using 3 cleaning techniques, BIPM *nettoyage-lavage* [2], UV Ozone [3] and H-plasma [4]. The results of the measurements ( $S_a$ ) are shown in figures 17 to 19 (results from the solid materials investigated are also shown for comparison).

Similar to the results from laser scattering, the results for the two plated samples (Au(ep) and Rh(ep)) measured with a white light microscope are significantly rougher than the samples produced from solid materials.

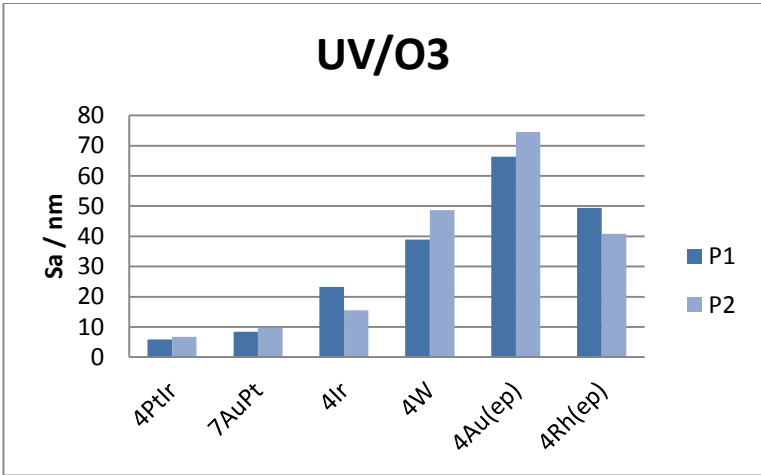
Figure 18.  $S_a$  surface roughness values for UV/Ozone cleaned samples (measurements taken at 2 positions, P1 and P2, on the sample surface).

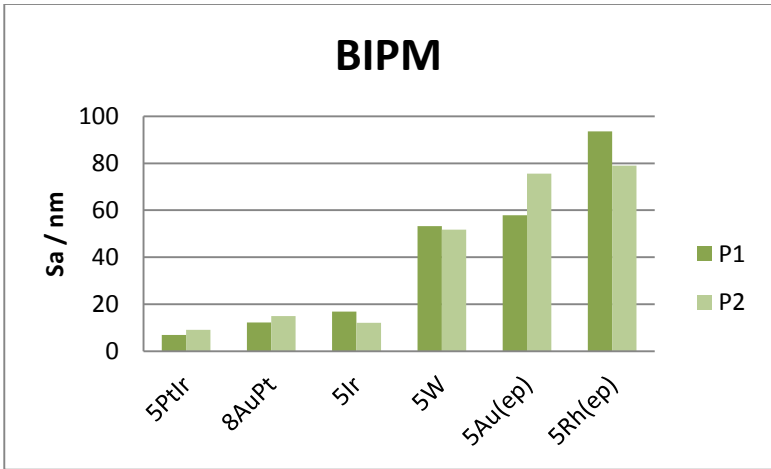
Figure 19.  $S_a$  surface roughness values for samples cleaned by *nettoyage-lavage* (measurements taken at 2 positions, P1 and P2, on the sample surface).

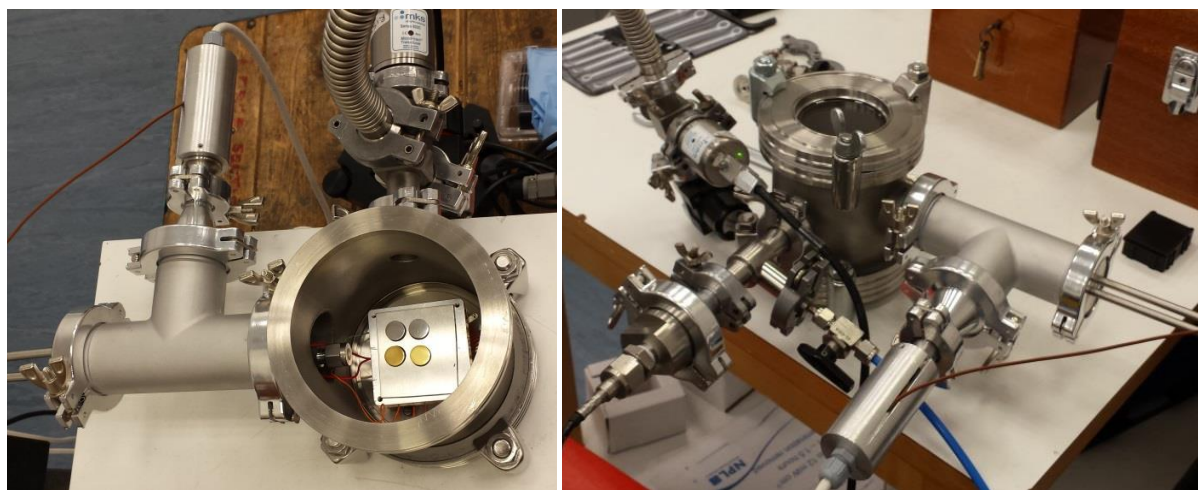
**Figure 22. Apparatus used for vacuum/humidity cycling.**

Since the intention is for new mass standards to be comparable with use in air and vacuum the effect of humidity and pressure cycling in the integrity of the plated overlayers was assessed. Before initiating the vacuum/humidity cycles, two gold and two rhodium plated samples were surface mapped (total surface area for each sample of approximately  $2\text{ mm} \times 2\text{ mm}$ ) and their surface roughness parameters measured with a confocal laser microscope using a  $\times 50$  optical lens. Five cycles were performed: the samples were cycled between vacuum (pressures of about  $0.4\text{ Pa}$ ) and atmospheric pressure at a relative humidity of about 60 %. The samples were left for about 1 hour in each environment. After the 5 cycles, the samples were again analysed using the same technique. Figure 20 shows the apparatus used for the vacuum/humidity cycling of the samples.

Although thermal cycling of (plated) mass standards is not envisaged in normal use following the vacuum/humidity cycling test the apparatus shown in figure 20 was also used to thermally cycle the samples. As before the samples were surface mapped (total mapped each sample approximately  $2 \text{ mm} \times 2 \text{ mm}$ ). Five thermal cycles were performed in which the samples were subjected to a maximum temperature of about  $160^\circ\text{C}$  for about one hour then cooled back to ambient temperature (about  $20^\circ\text{C}$ ). Heating the samples to  $160^\circ\text{C}$  from ambient took approximately 30 minutes and the cooling took 2-3 hours.

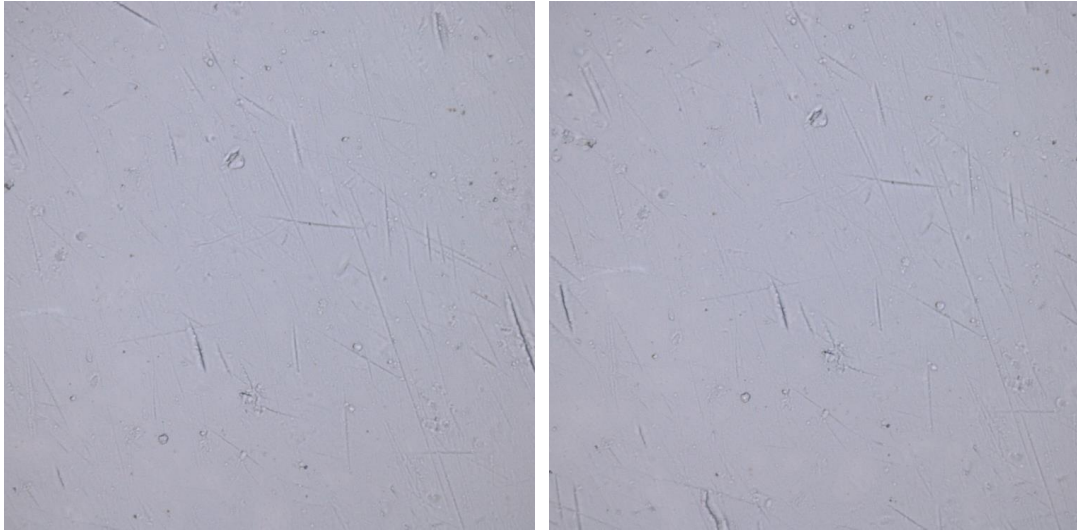
**Figure 21. Rhodium plated sample before (left) and after (right) vacuum/humidity cycling.**

All four surface samples were examined. Figures 21 and 22 show images with a surface area of approx.  $0.22\text{ mm} \times 0.22\text{ mm}$  taken before and after cycling.

Visually no changes in the surface were observed comparing the images before and after cycling. Table 3 summarises the surface roughness data acquired.

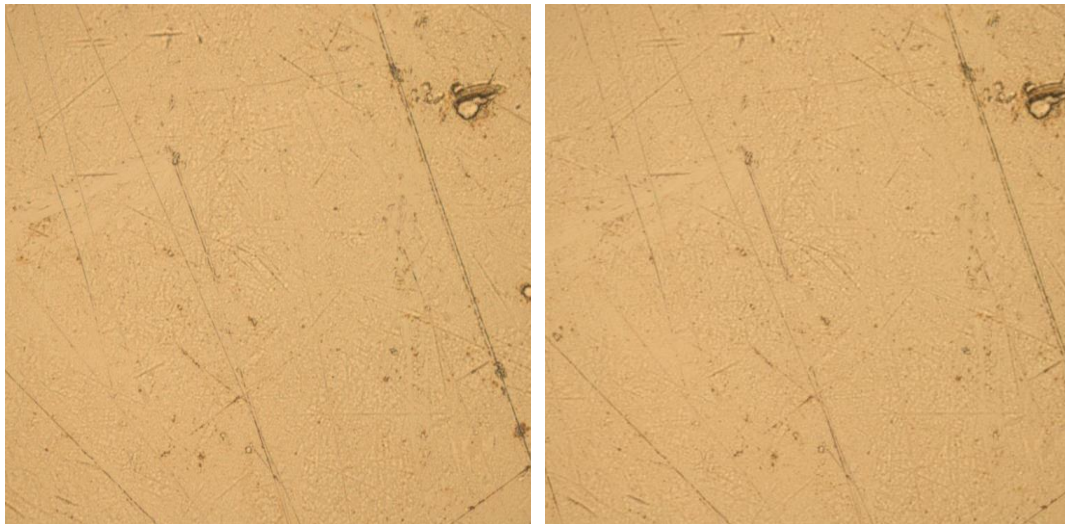
**Figure 22. Gold plated sample before (left) and after (right) vacuum/humidity cycling.**

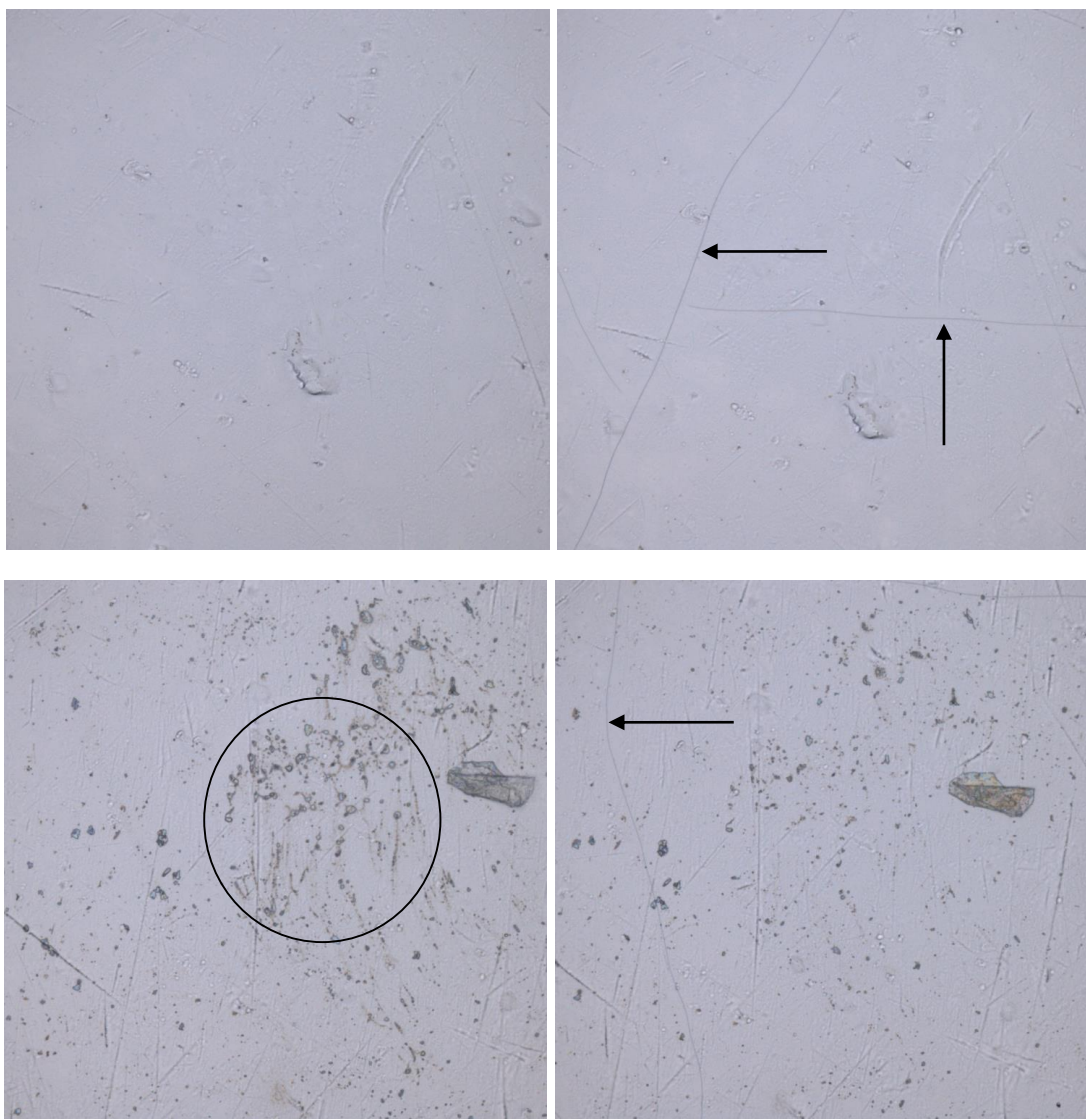
**Figure 23. Rhodium plated sample before (left) and after (right) thermal cycling.**

The two rhodium scans show additional fine cracks following thermal cycling (indicated by the arrows in the right hand images). The images following thermal cycling also indicate that the samples are significantly cleaner, illustrated by the removal of contamination (circled) from the before cycling sample area. This is due to the thermal desorption of surface contamination during the thermal cycling process.

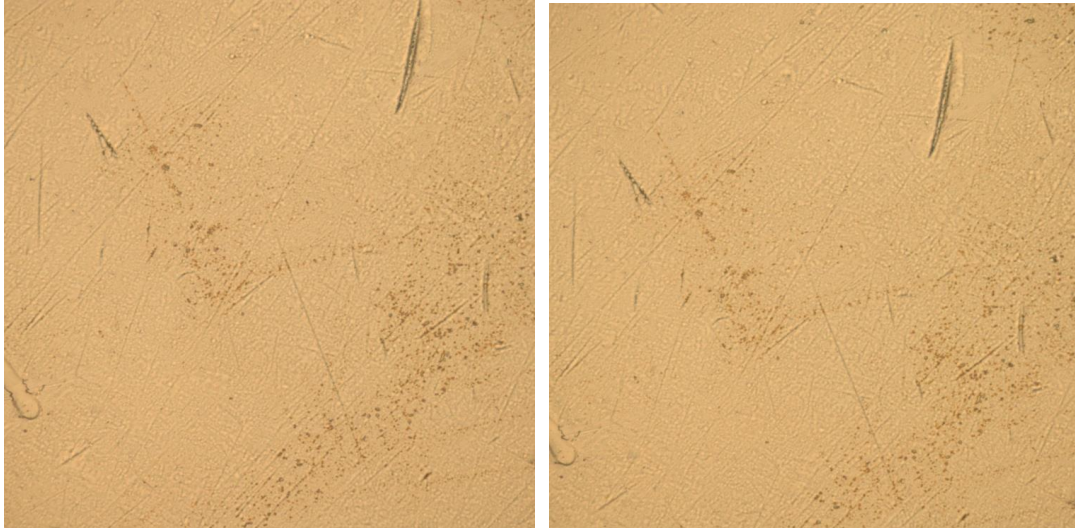
**Figure 24. Gold plated sample before (left) and after (right) thermal cycling.**

The gold samples show no additional cracks after thermal cycling but again the post-cycling images show slightly cleaner surfaces.
